A STUDY ON CHURCHES, continued

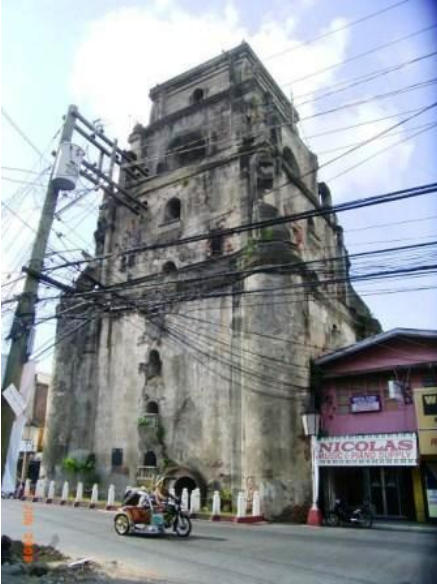
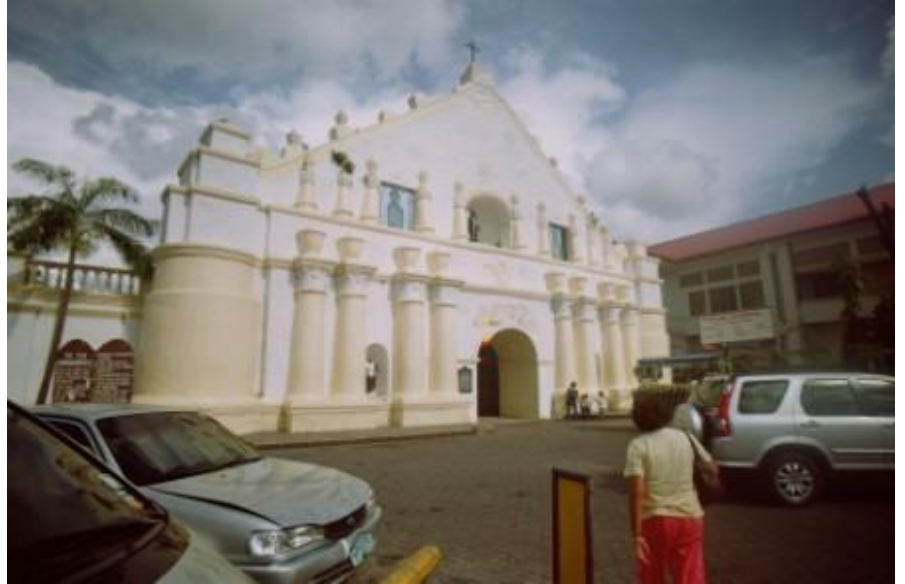
The Laoag bell tower is separated from the main church by a street. The church exterior has been modernized but the basic structure remains intact. Foundation was laid in 1612. See plaque below, right.

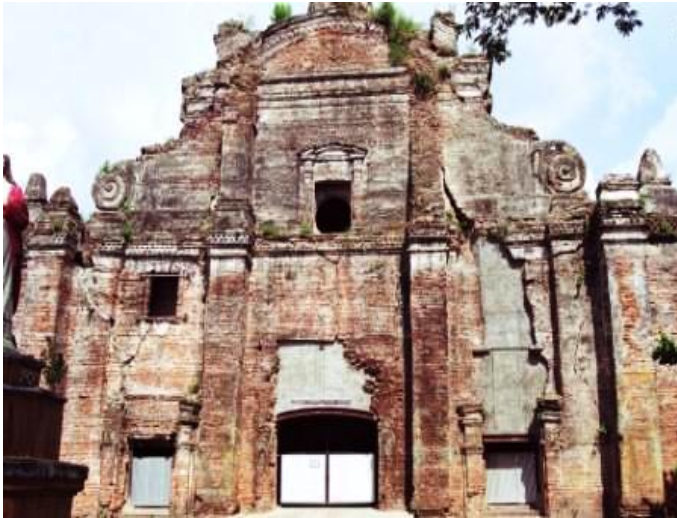
The church in Dingras (above) is all original, but condemned, rendered unsuitable for use by some earthquake decades ago. The bell tower of the Bacarra church (above right) also is damaged; the top portion fell off in an earthquake fairly recently, with the debris still is on the ground. But the church façade is all modern and spruced up (below), while the side walls are still original with stone/brick and buttresses (below).

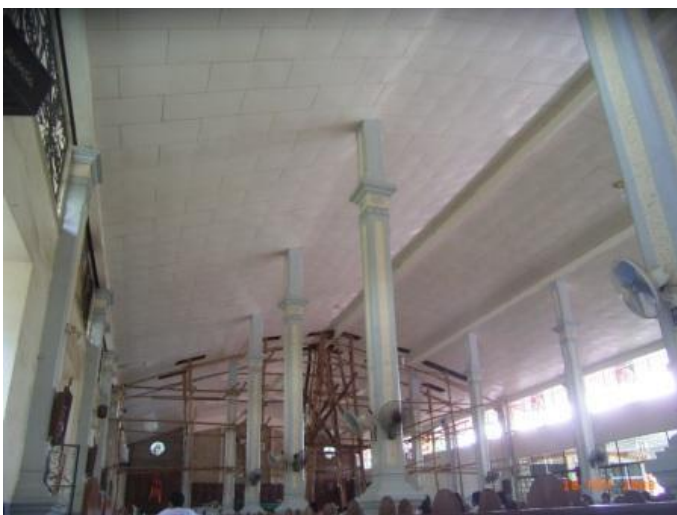
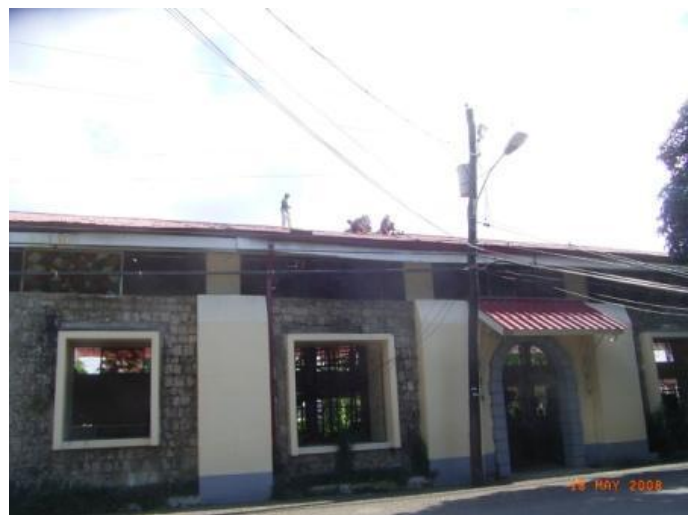
As for the Tanjay church, see below. Four pillars have been removed by the present parish priest, without a building permit, or structural calculations, or public hearing. Had it not been for the public's vigilance, he would have removed all the pillars after some unknown truss repair. Hopefully, in the event of an earthquake, it will not go the way of the Dingras church or Bacarra tower. We should put back those pillars.
