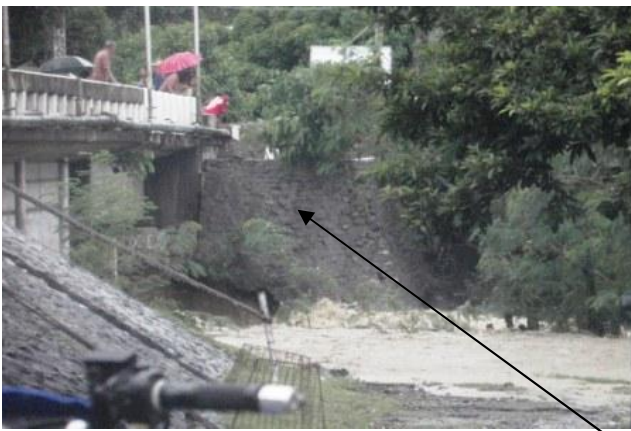
Main bridge at height of flood. Note embankment

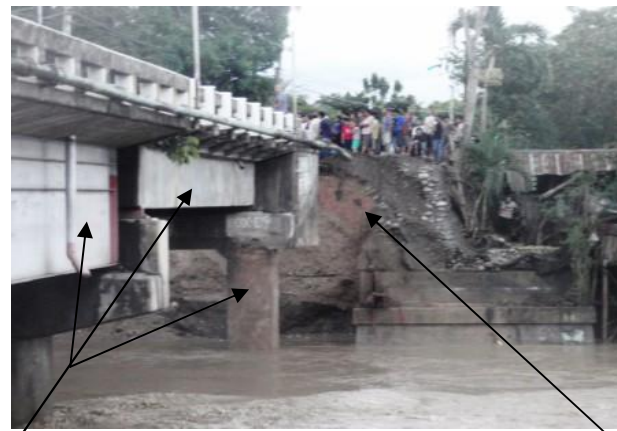
Later, water subsided but embankment eroded while steel beams and concrete pylons remain intact.

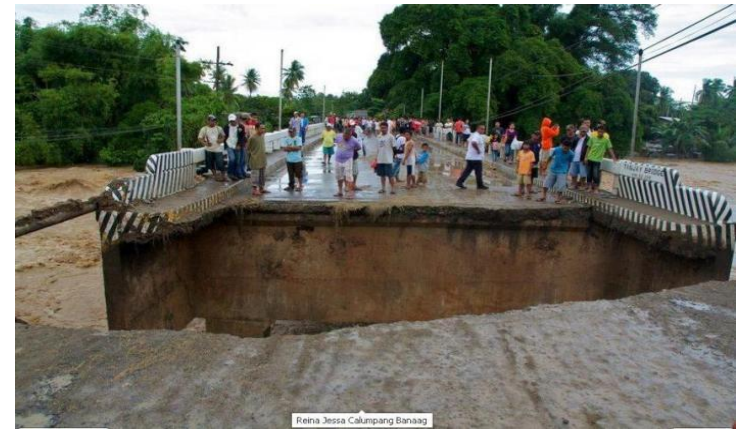
View from the eroded side of the bridge

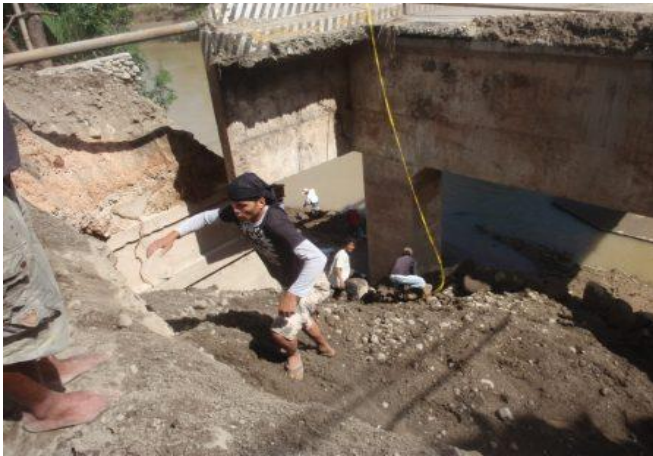
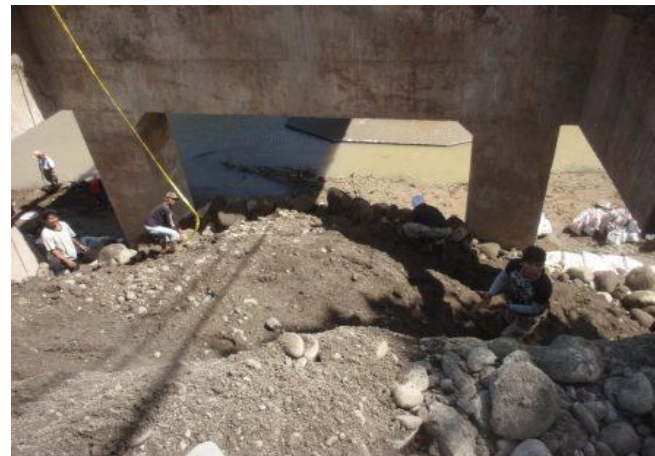
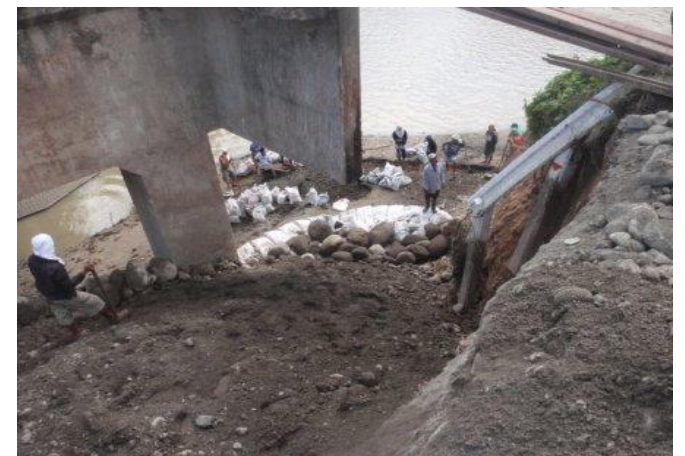
Left, middle & right views of eroded side of bridge, Dec 19. Dept of Public Works personnel working to build back retaining wall and embankment.

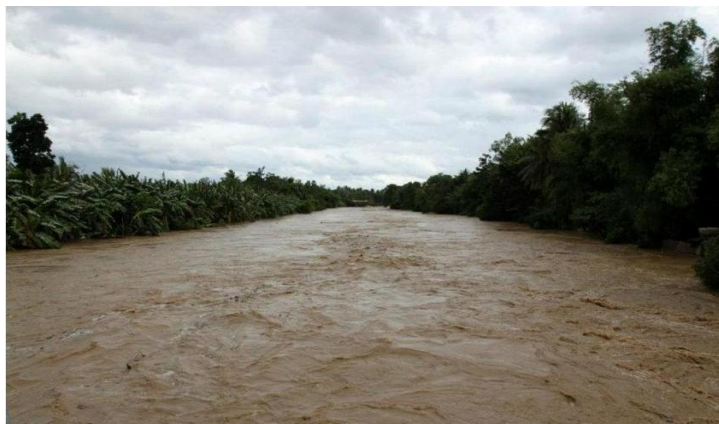
Down stream view from New Tabuc bridge, height of flood

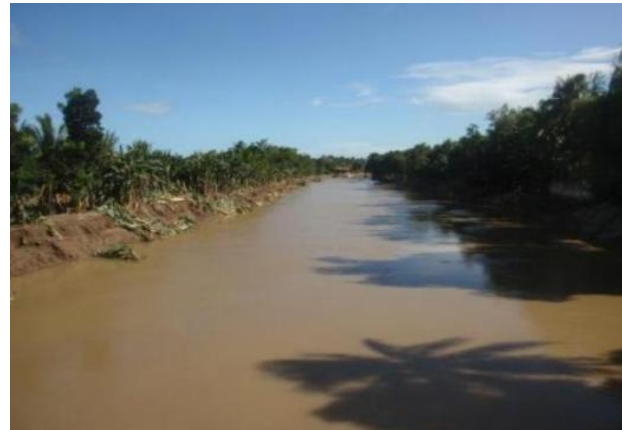
Same view after flood receded

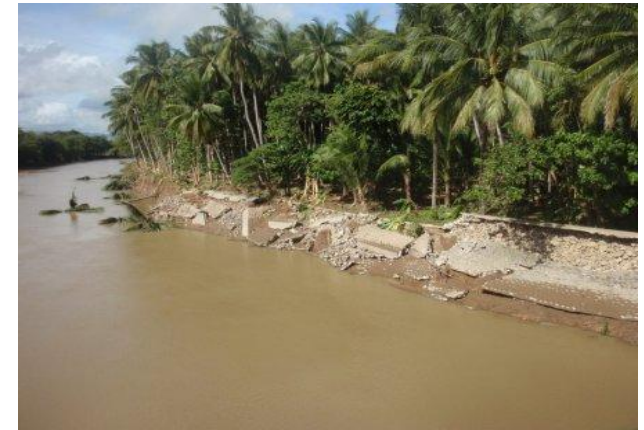
Up stream view of damage, Tabuc side

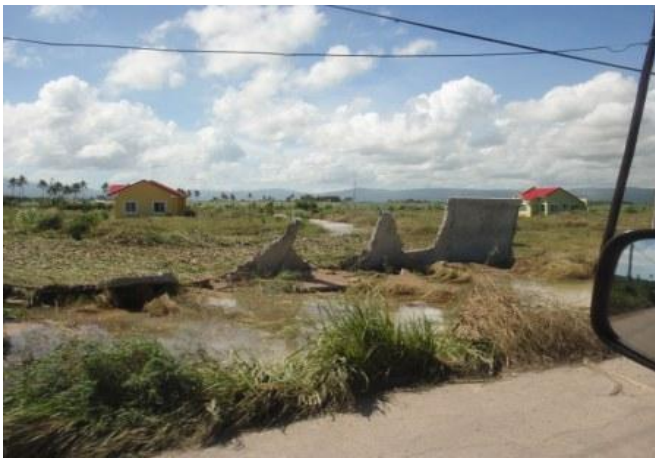
Downed concrete fence, subdivision along Tabuc road

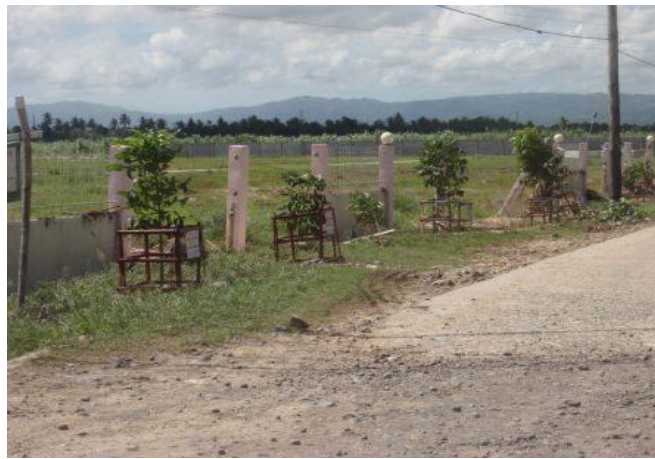
Downed portion of Serenity Cemetery side fence

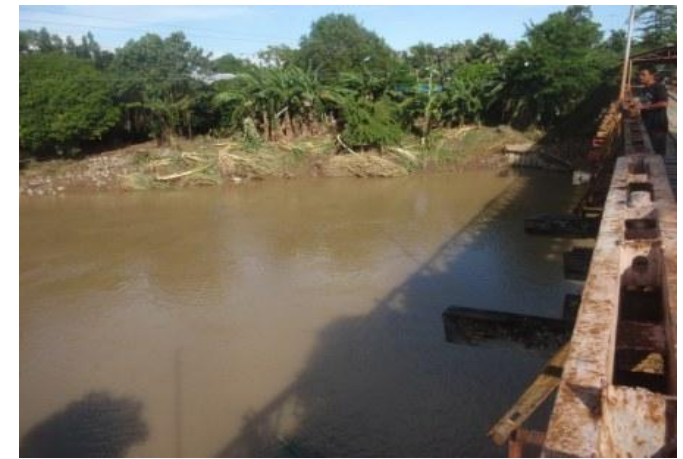
View from Old Tabuc bridge
