A STUDY ON CHURCHES, continued

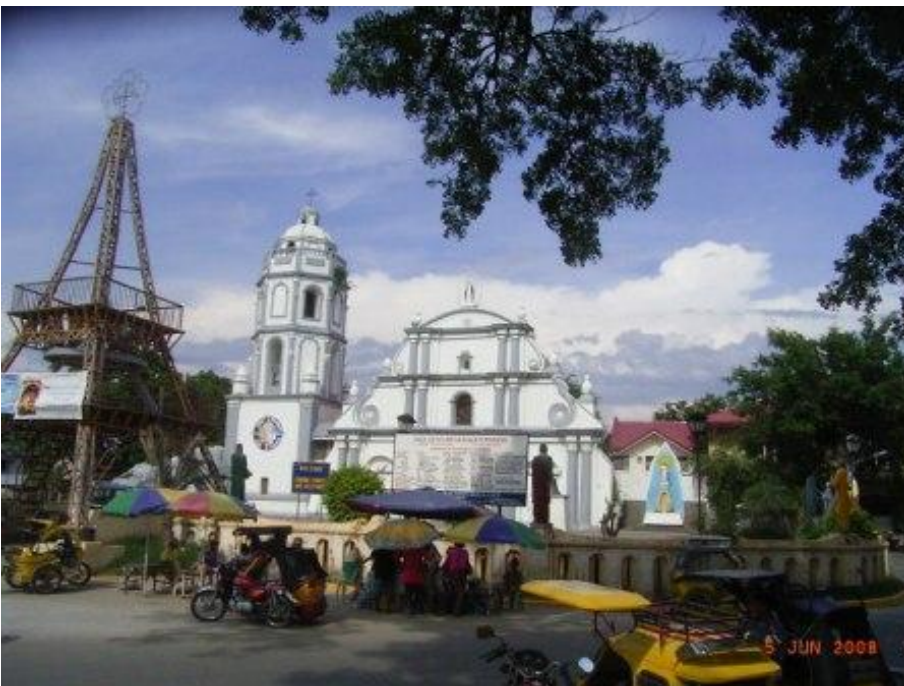
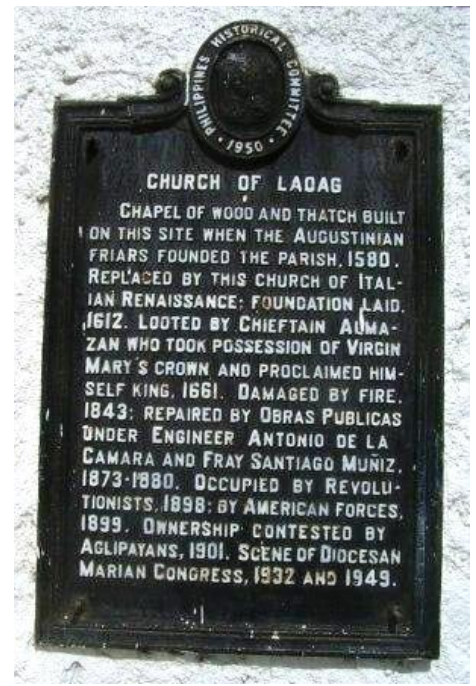
The Laoag bell tower is separated from the main church by a street. The church exterior has been modernized but the basic structure remains intact. Foundation was laid in 1612. See plaque below, right.

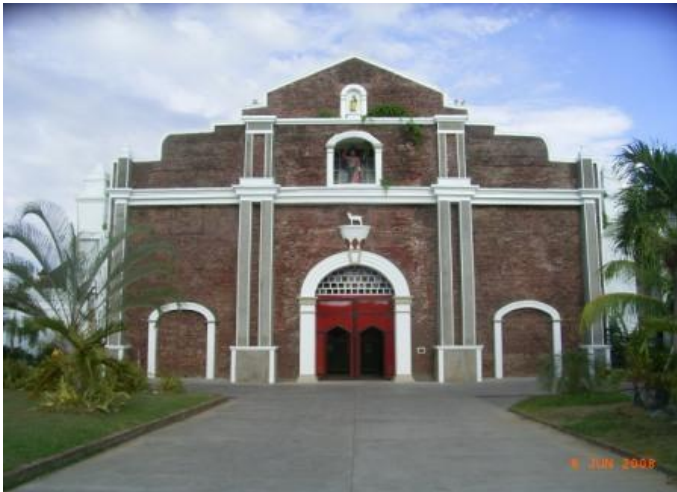
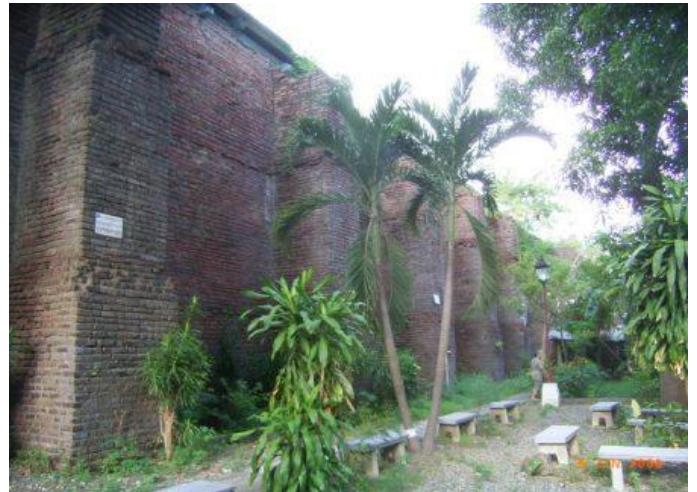
The church in Dingras (above) is all original, but condemned, rendered unsuitable for use by some earthquake decades ago. The bell tower of the Bacarra church (above right) also is damaged; the top portion fell off in an earthquake fairly recently, with the debris still is on the ground. But the church façade is all modern and spruced up (below), while the side walls are still original with stone/brick and buttresses (below).
